## SERVICE BULLETIN NO. RSB1078-217

G115E/EG all S/N

ATA-Code: 53-10 Fuselage Structure  
Inspection of PVC Cable Conduit

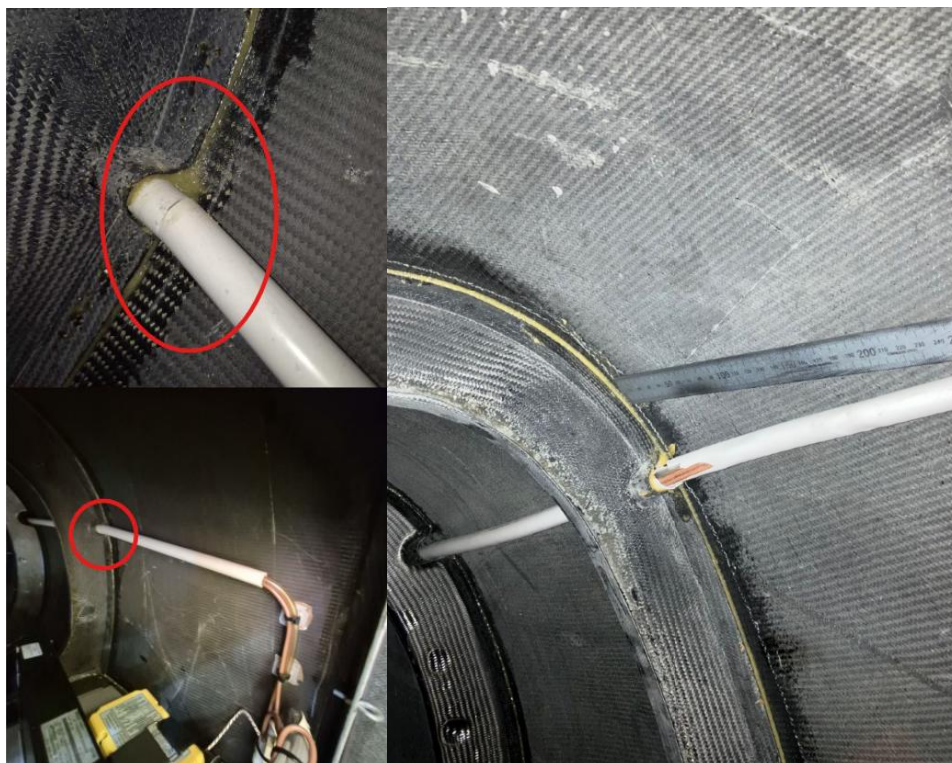
Due to aging, the PVC cable conduit may become brittle and crack. This Service Bulletin includes inspection and, if necessary, the replacement of damaged conduit. The configuration of the aircraft is affected by this Service Bulletin.

- 1.8.1 Make the aircraft safe for maintenance, refer to AMM Chapter 10-10.
- 1.8.2 Open the rear equipment compartment access panel for access to the rear fuselage. Refer to AMM Chapter 25-10.
- 1.8.3 Inspect the PVC Cable Conduit for damages.
  - If the PVC Cable Conduit is damaged or worn, continue with Step 1.8.4.
  - If the PVC Cable Conduit is intact, proceed to Step 1.8.11.
- 1.8.4 Remove the PVC Cable Conduit with a suitable tool. If the section of the PVC Cable Conduit attached to the inside of the frame is undamaged, leave it in place. Carefully cut the PVC Cable Conduit in front of and behind the frame.
